THE EFFECT OF DEFECTS AND DAMAGES IN REINFORCED CONCRETE LOAD-BEARING STRUCTURES ON FURTHER OPERATING CONDITIONS

The purpose of this study is to inspect a specific student dormitory with subsequent assessment of the technical condition category of reinforced concrete structures based on the results of identified defects and damage.

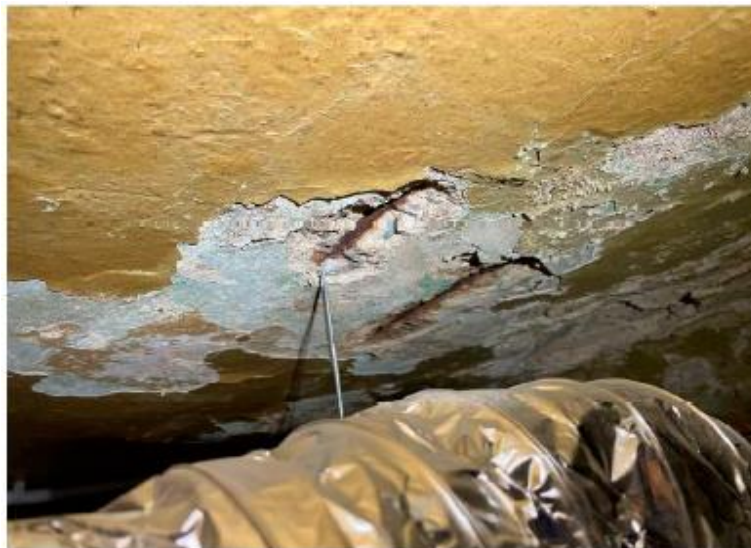
- 1) corrosion of steel reinforcement, especially a high percentage of corrosion (Fig. 1);
- 2) damage to the protective layer of concrete (Fig. 2);
- 3) punching of holes in floor slabs for laying communications (Fig. 3);
- 4) non-compliance of reinforcement with design documentation;
- 5) poor quality execution of support units of horizontal load-bearing structures (beams, slabs, trusses).

Fig. 1. Corrosion of the reinforcement bars of the floor slab

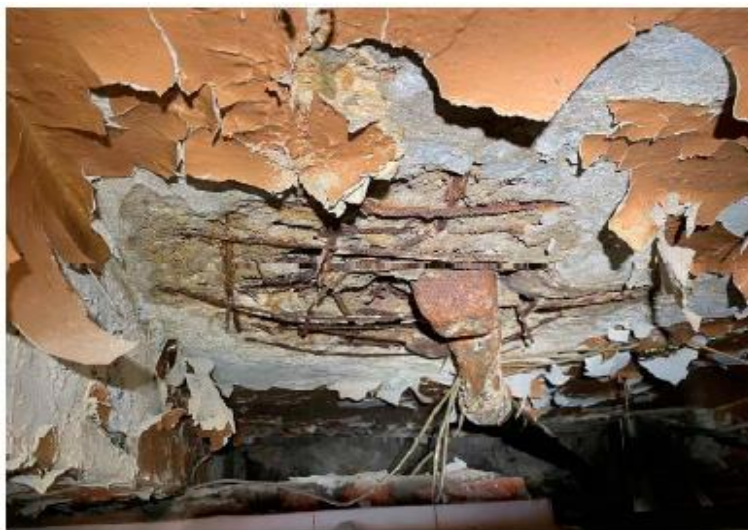
Fig. 2. The absence of a protective layer of concrete in the floor slab

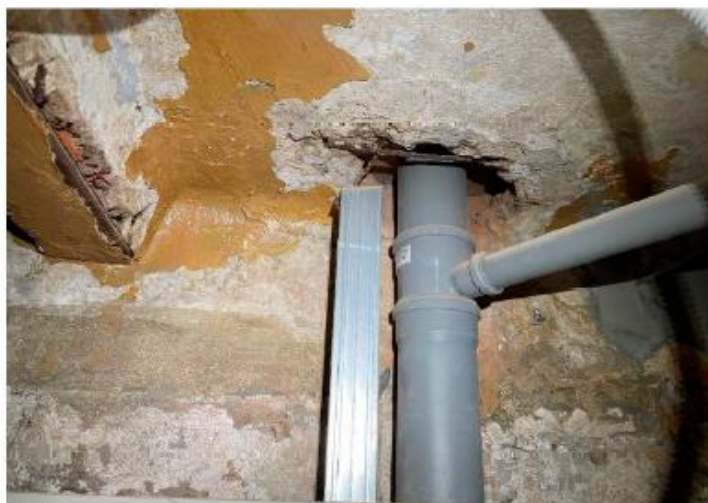
Fig. 3. Punching a hole in the floor slab for laying communications

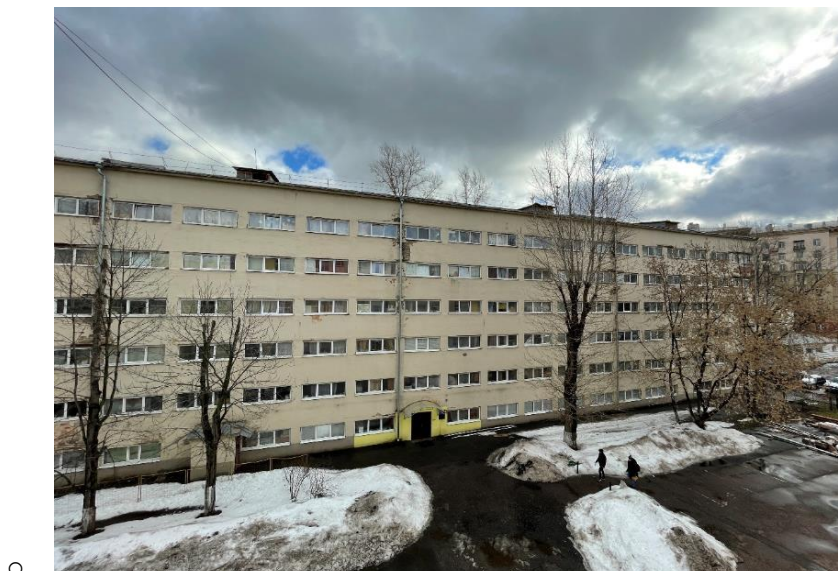
Fig 4. The object of the survey

To assess the impact of defects on further operating conditions, the building of a student dormitory in Moscow is considered as the object of examination in this work (Fig. 4). The building has a mixed load-bearing structural system consisting of a frame [XI] and load-bearing walls (Fig. 5).

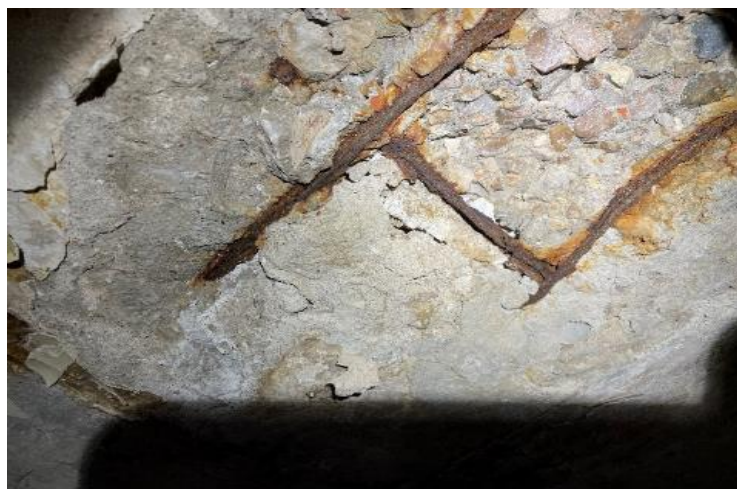
- Intensive soaking.
- Multiple punched holes for laying communications are made by cutting out the working reinforcement without a frame.
- Crack formation areas.
- Damage to the protective layer of concrete.
- Corrosion of reinforcement with a loss of cross-section up to 50%.
- Use of gravel and large pebbles as coarse aggregate, settling of coarse aggregate on the lower plane of the slab (uneven vibration) (Fig. 6).

The causes of the above defects are long-term exposure to temperatures and humidity [XII], untimely routine repairs, poor quality installation work on the installation of beams to reinforce the floor slab, and work carried out without design documentation. Recommendations for eliminating defects in the monolithic floor slab are as follows: due to multiple defects in the monolithic floor slab, it is recommended to dismantle it and then install a new floor on metal beams (Fig. 7).

Fig 6. Monolithic floor slab (showdown)

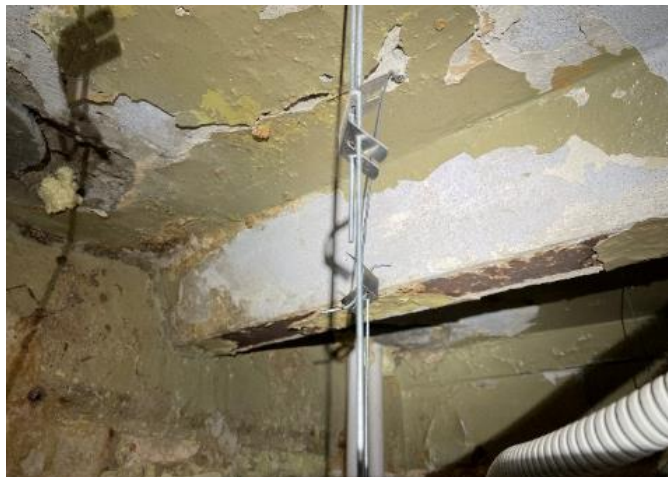
Fig 7. Monolithic floor slab on steel beams

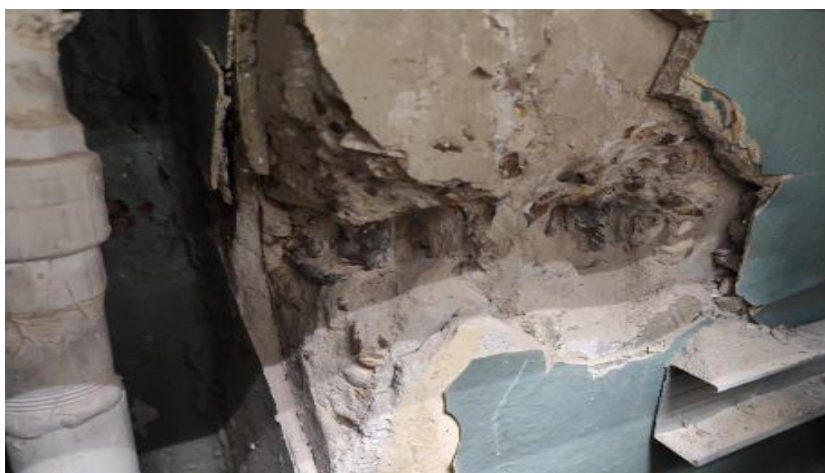
During the inspection of monolithic columns, the following defects and damages were identified (Fig. 8, Fig. 9):

- Insufficient size of the protective layer of concrete.
- Corrosion of reinforcing bars of columns with a loss of section up to 20%.
- The destruction of the protective layer of columns near the column base device for a length of up to 2 m (because of which the stability of the reinforcing bars may be lost, including due to the lack of adhesion of the reinforcement to concrete).
- The use of gravel and large pebbles of different fractions as a coarse aggregate. Areas of local accumulation of large aggregate and its uneven distribution over the concrete body were found, which leads to large variability in strength indicators.

The causes of these defects are prolonged temperature and humidity exposure, violation of the technology of concrete work, and untimely carrying out of current repairs [VIII, XII].

Fig 8. Monolithic column

Recommendations for eliminating these defects will be to strengthen the columns using a steel frame made of rolled elements. Reinforcement bars must be cleaned of corrosion and treated with corrosion inhibitors. The protective layer of concrete of the columns must be restored with a repair compound to the standard value.

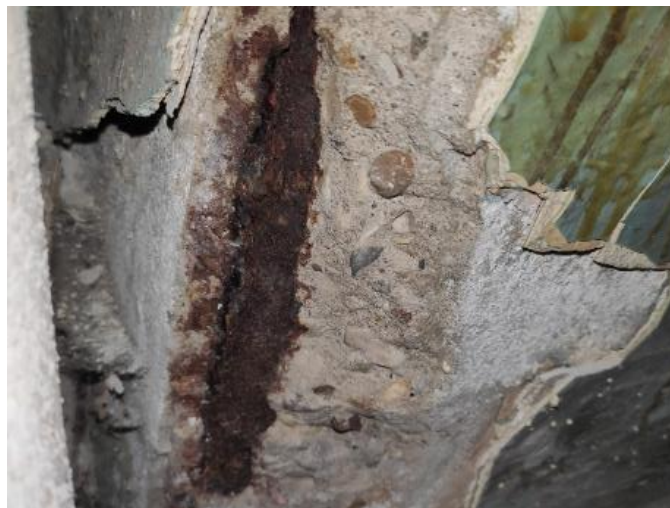
Fig 9. Monolithic column (enlarged view of the reinforcing bar)

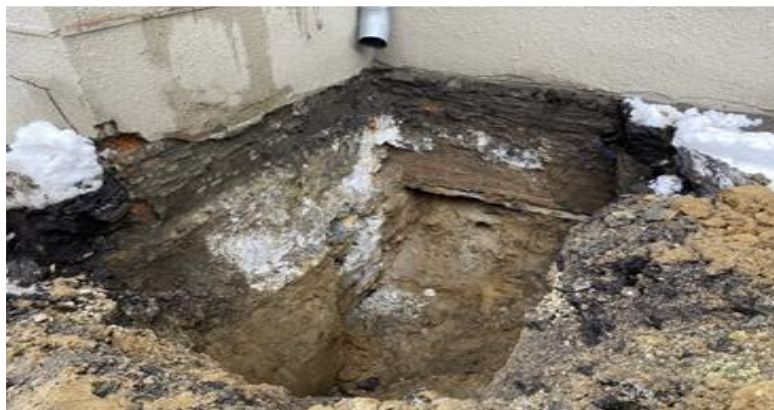
The foundations of the columns of the building are columnar, made of monolithic reinforced concrete (Fig.11). The foundations of the longitudinal exterior walls of the building are ribbon, made of monolithic reinforced concrete (Fig.10).

- Lack of waterproofing of the foundations, which is contrary to regulatory requirements. As a result of the lack of vertical and horizontal waterproofing of the surface of concrete and rubble foundations, when exposed to surface water, the foundation body becomes moistened, which over time leads to a decrease in the operational suitability and accelerated wear of concrete and rubble foundations, erosion of the masonry mortar and loosening of the masonry (formation of cavities, peeling and falling out of stones [XV]).

- In places where water is discharged from the roof through drainpipes onto the building's blind area, external pits are dug. Near the spillway zones, localized areas of destruction of the masonry mortar to a depth of up to 20 mm were found. Areas of leaky connections of the blind area with the external walls were discovered, which led to systematic moistening of the foundation and its destruction.

Fig 10. The foundation for the external wall

- Due to the long-term operation of foundations without waterproofing, local areas of destruction of the mortar of masonry joints, as well as to increase durability and operational suitability, it is recommended to fix the rubble masonry of foundations by installing a concrete protective cage, for example, by shotcrete (or an alternative method).
- Perform waterproofing of monolithic and rubble foundations, as well as brick walls located below the ground surface and in contact with the backfill soil.
- Seale the joint between the blind area and the external walls to reduce the negative impact of surface water on the rubble masonry of the foundations.
- Develop measures for the installation of drainage (for example, the installation of a storm drainage sewer along the perimeter of the building).

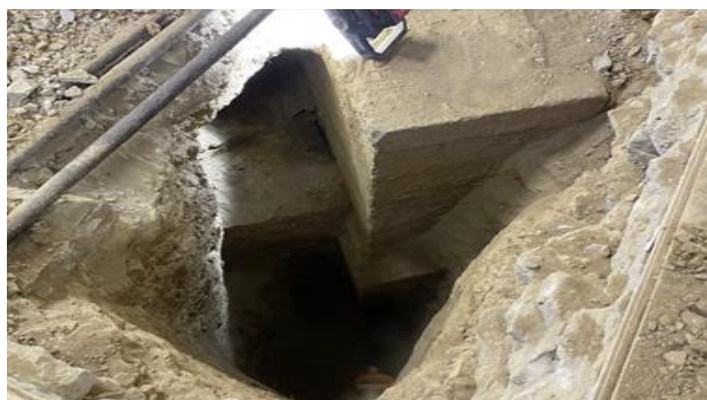
Fig 11. The foundation for the central column
